ROSS DAM

NDI ID NO. PA-00978
DER ID NO. 58-134

PHASE I INSPECTION REPORT
NATIONAL DAM INSPECTION PROGRAM

DEPARTMENT OF THE ARMY
Baltimore District, Corps of Engineers
Baltimore, Maryland 21203

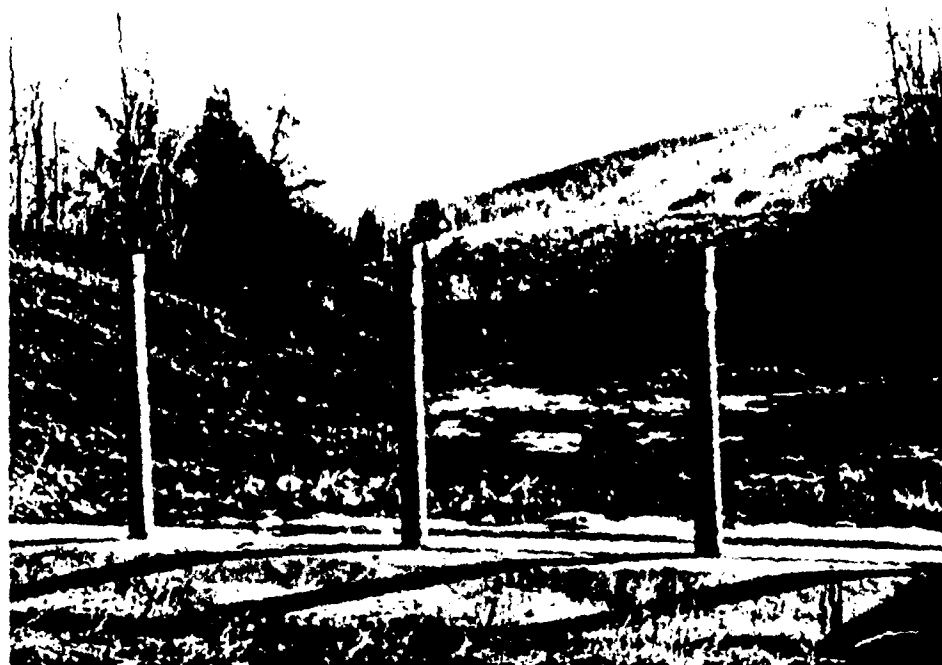
7. Spillway of large channel. Barn on left and weir in foreground.

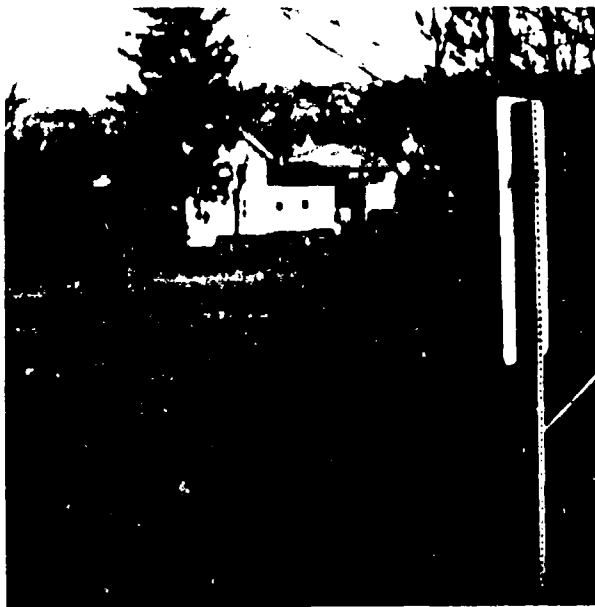
12. Second downstream residence.
